# Manhole Inspection Summary

Manhole # S27E\_\_047MH

Insp Date: 1/15/09 11:28 AM

**Location** Address: **104 Vine St.**

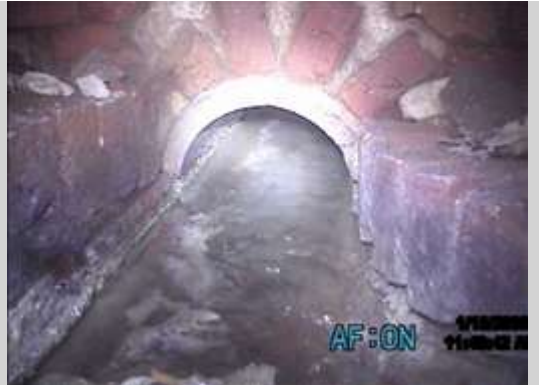
12 O'Clock Outflow

8 in. Circular Gravity Sewer  
Pipe Out @ 12 O'Clock

Pipe Material: **Clay** ☐ Pipe Lined

Invert Depth: **9.50** (ft.) Flow Characteristics: **None**

Deposits: ☒ None ☐ Mud ☐ Gravy ☐ Debris ☐ Grease

Infiltration: **None** Pipe Seal Cond: **Sound**

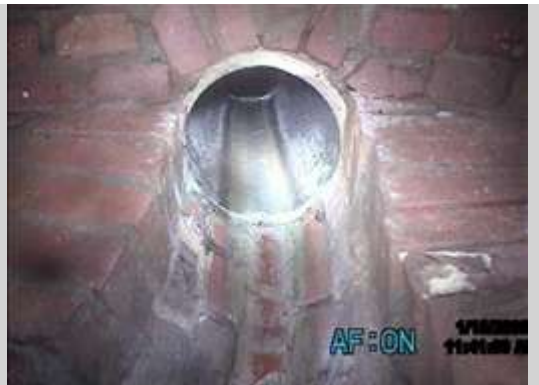
3 O'Clock Inflow

8 in. Circular Gravity Sewer  
Pipe In @ 3 O'Clock

Pipe Material: **Clay** ☐ Pipe Lined

Infiltration: **None** Pipe Seal Cond: **Sound**
